CYCLONE TESTING STATION

TESTING A HIGH SET HOUSE DESIGNED FOR 42 m/s WINDS

Part 1 - Preliminary Results

Technical Report No. 19

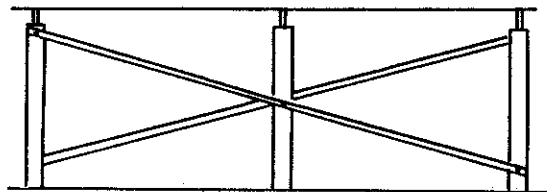
(a) Originally installed

*timber braces  
fixed with one  
16 mm masonry  
anchor each end*

chemical anchors and the bracing system performed well for the remainder of the above floor tests.

At the completion of the tests on the house above floor level, all of the abovementioned temporary bracing was removed. Where concrete had been broken, it was replaced with high strength concrete grout, and the timber braces on columns K1, K2 and K3 changed to the other face of the column where the concrete was undamaged. This also enabled the masonry anchors
